April 19, 2004

Site Inspection, Rock-It Stone, Strawberry River Quarry,

S/013/008, Duchesne County, Utah

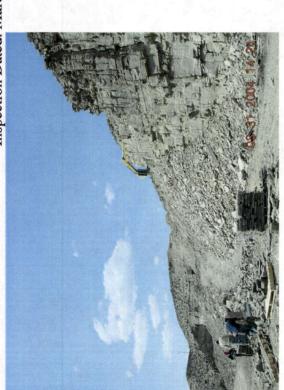
During the inspection, five workers were bringing stone from near the east end of the quarry/highwall down to a processing area that extends south from the base of the highwall (Photo 1). (Please note that the clock on the camera was apparently set for daylight savings time, so the time on the photos is one hour off.) Equipment on site included a trackhoe and a front end loader.

Photo 1. A portion of the stone processing area and the rubble pile at the base of the highwall. Note the trackhoe arm just to the right of center.

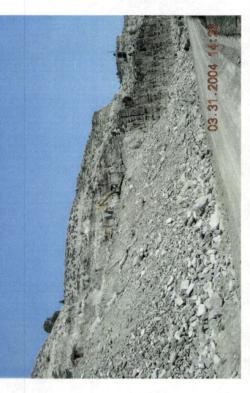
Photo 3. View from the opposite angle as Photo 1.

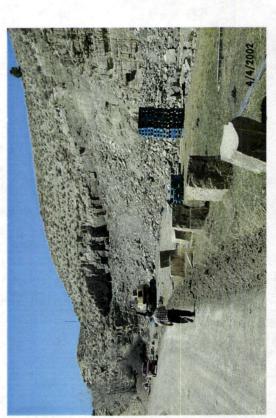
Photo 2. Photo from April 2002. Compare to Photo 1.

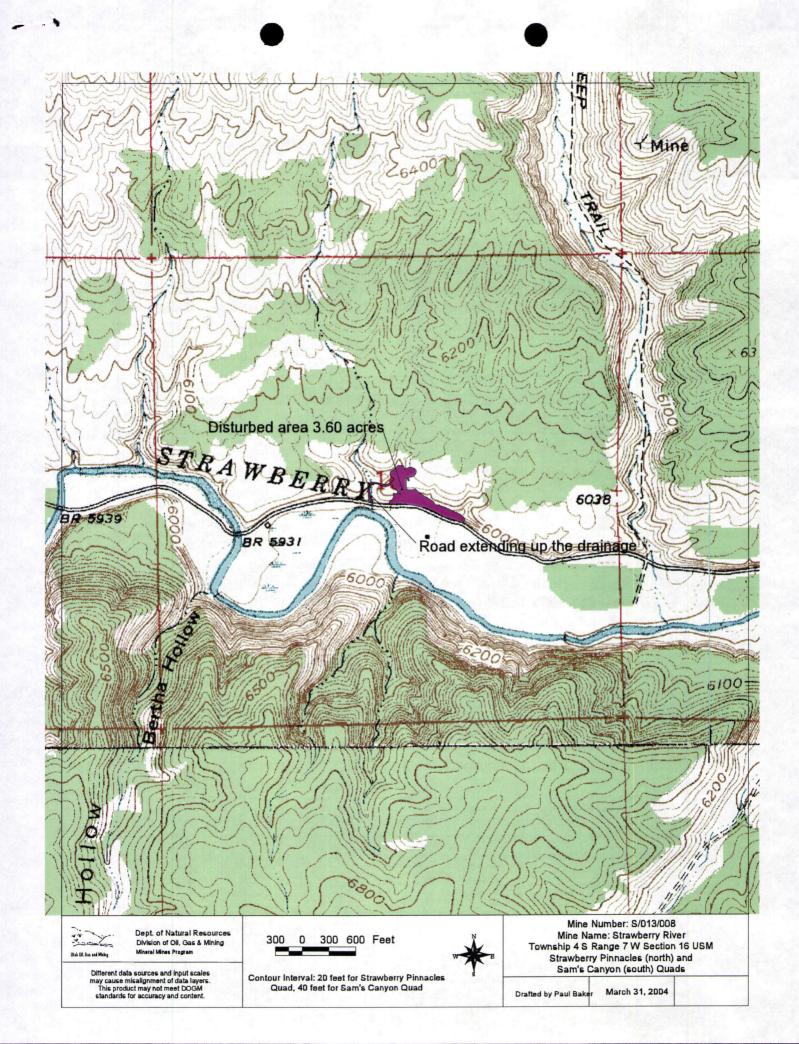
Attachment: map

I walked around the disturbed area with a Geo Explorer 2 GPS unit and later transferred and corrected this data to make the attached map. To obtain satellite readings, I was not able to walk right next to the highwall, but I was able to get readings surprisingly well. The disturbed area was measured as 3.60 acres.

On the attached map, there is a narrow piece of disturbed area that is hardly visible. It is a road that extends through the ephemeral drainage right next to the "Y" in "STRAWBERRY," through the "16," and it connects to the north part of the disturbed area.

Of greater concern is that it appears the operator could be trespassing. The map submitted with the NOI shows all operations being conducted on land owned by Bob Pinder in the NW¼ SE¼ of Section 16, Township 4 South, Range 7 West, USM. The GPS map clearly shows the operation extending into the northeast and southwest quarters of this section, and the NOI does not indicate whether the operator has right of entry for these areas.

In a certified letter dated September 5, 2003, I asked the operator to update the NOI with right of entry information. Since then, I have called the operator three times asking for this information. I telephoned Shannon Peatross on April 16, 2004, and asked him one last time for the update. If this is not forthcoming, a notice of noncompliance should be issued.
